Farha Roofing, LLC

8/28/2024 | 56 Photos

## 1028 East Harry

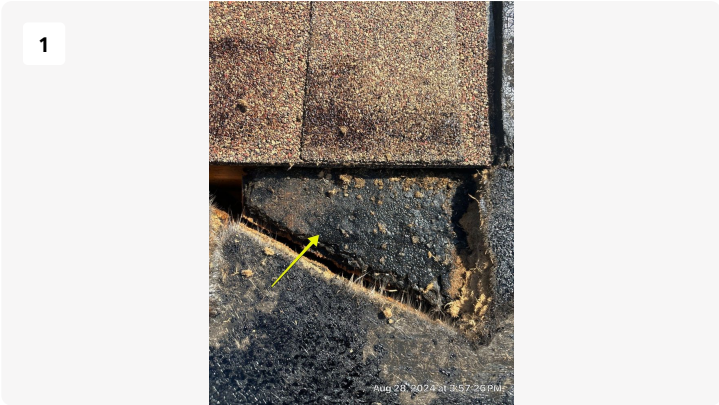
Plank wood deck.

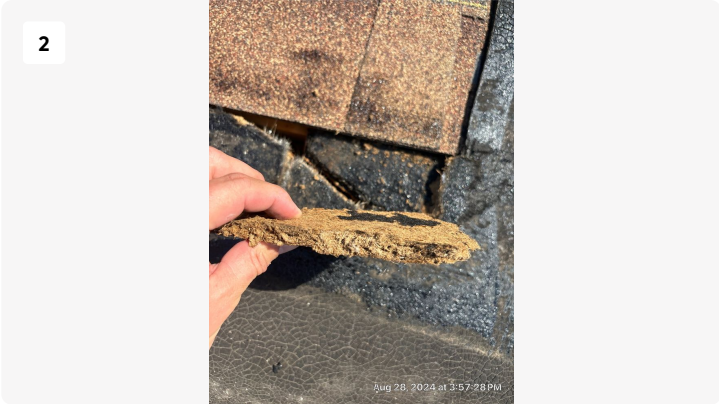
1/2" wood fiber.

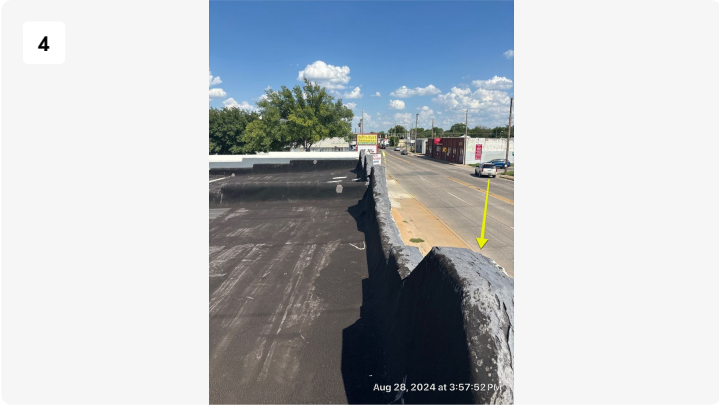
Wall termination and flashing failing.  
Will need new termination bar and or metal edge with new system.

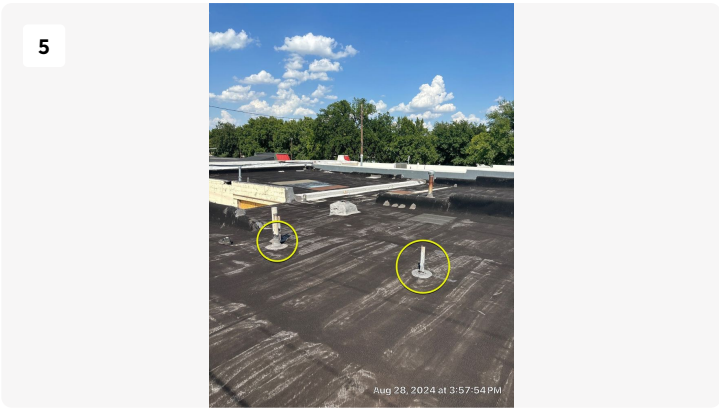
Soil vents need to be re flashed and or removed and replaced.

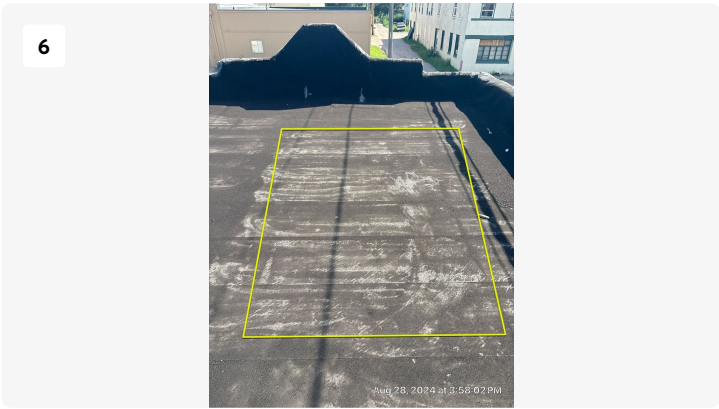
Fiberglass on built up cap sheet showing. Membrane is scrimmed out and is potentially an active leak.

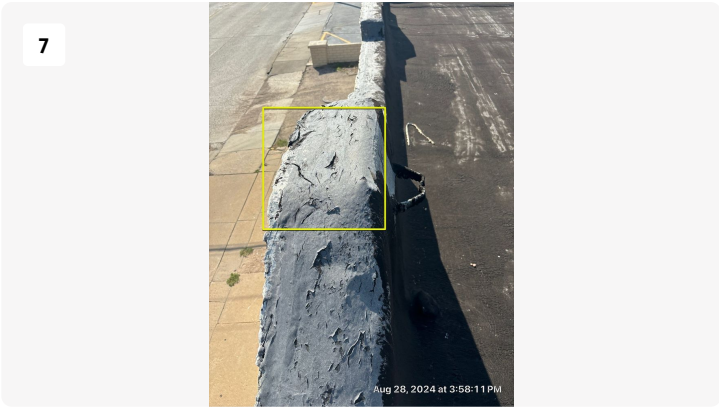
Additional photo of failing wall flashing.

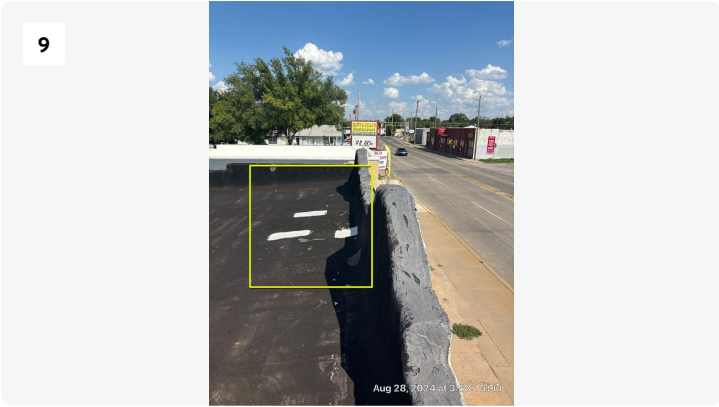
BUR cracking / alligating and has been repaired with lucas 8500.  
Not the correct application.

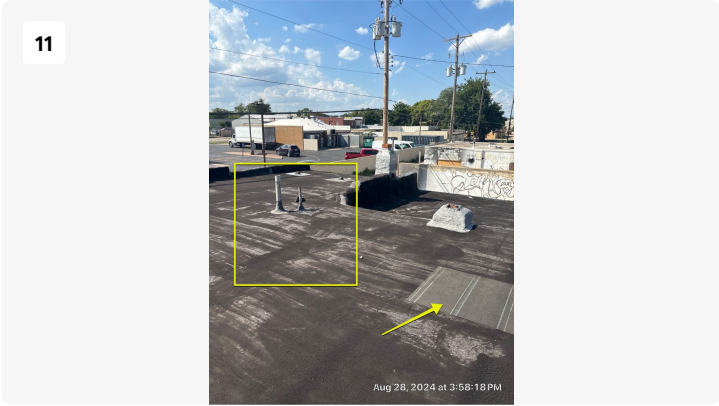
Shingle repair made on a low slope BUR.

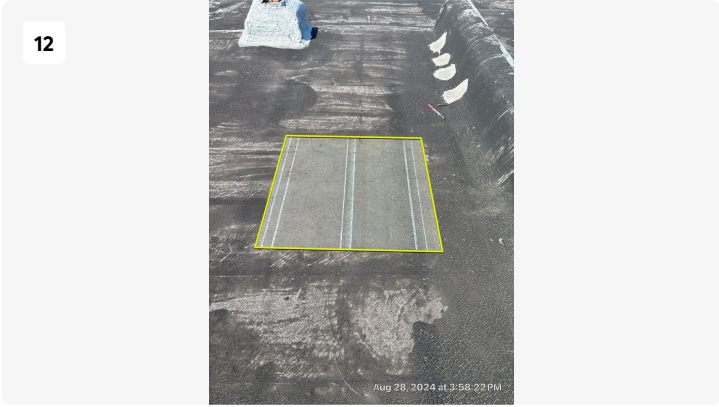
Shingle repair on a BUR roof.  
Not the correct application.

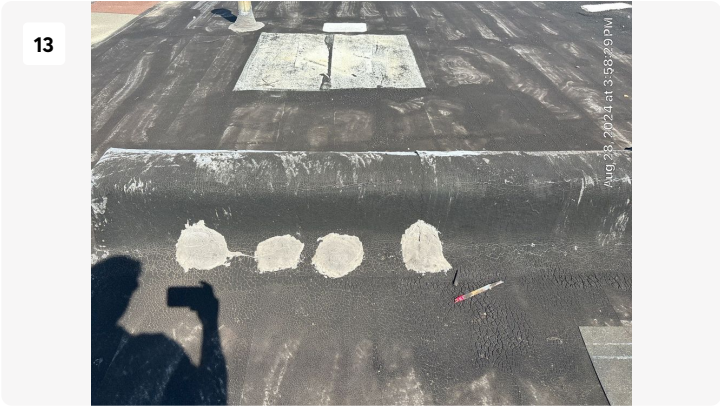
Wall flashing(s) with silicone on a BUR roof.  
Not the correct fix.

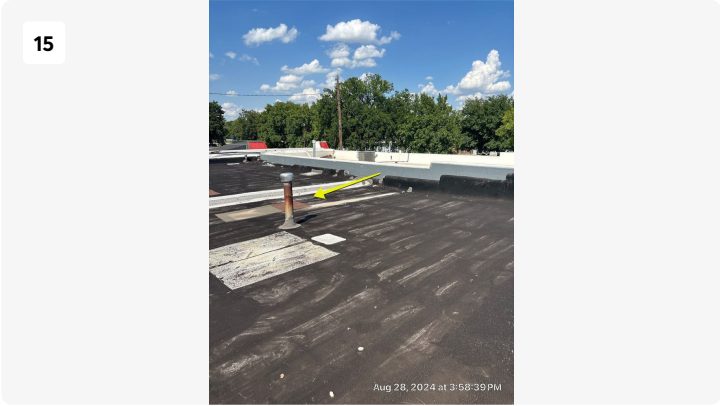
Rusted out vent cap, needs to be removed and replaced.

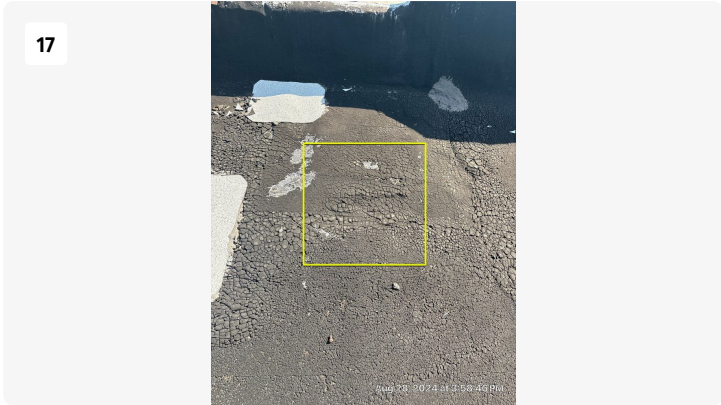
Membrane cracked out - alligating.

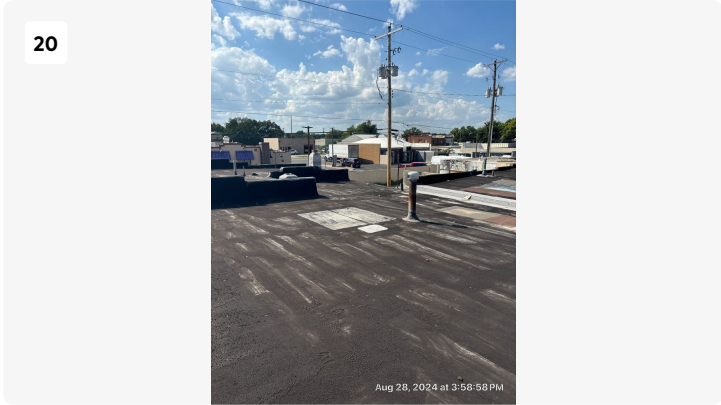
Additional photo of fiberglass and alligating.

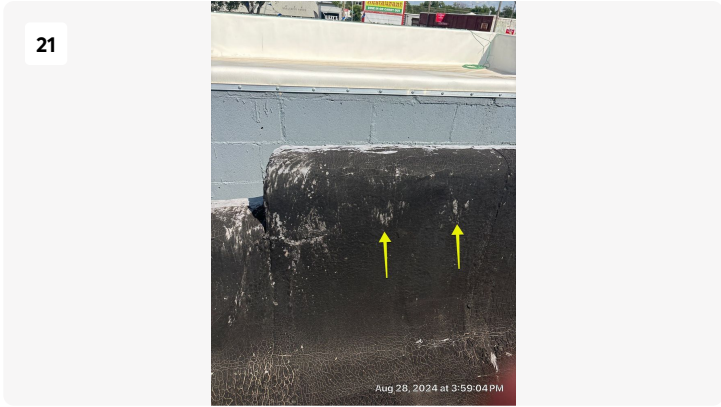
Failing wall flashing.

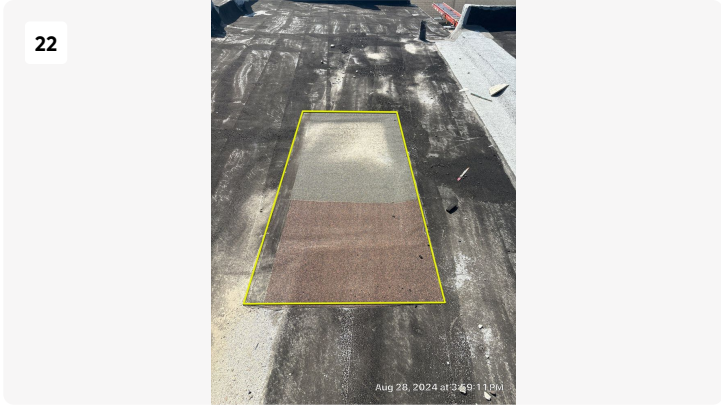
Shingle repair on a BUR roof.  
Not the correct application.

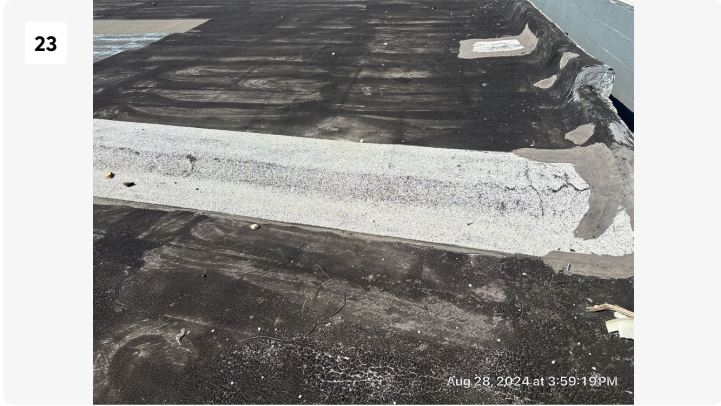
Angle changed stripped in with cap sheet. Needs to be touched up with roof cement.

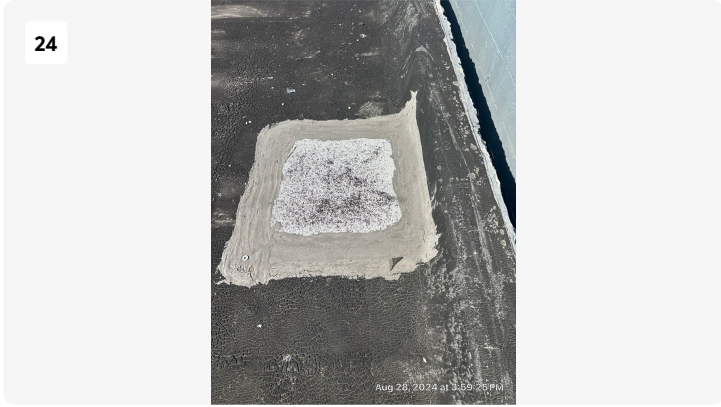
Deleted penetration stripped in with modified cap sheet and 3 coursed.

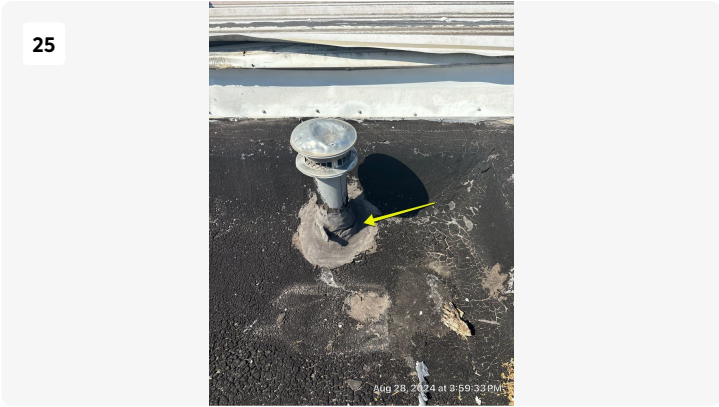
Penetration needs re flashed.

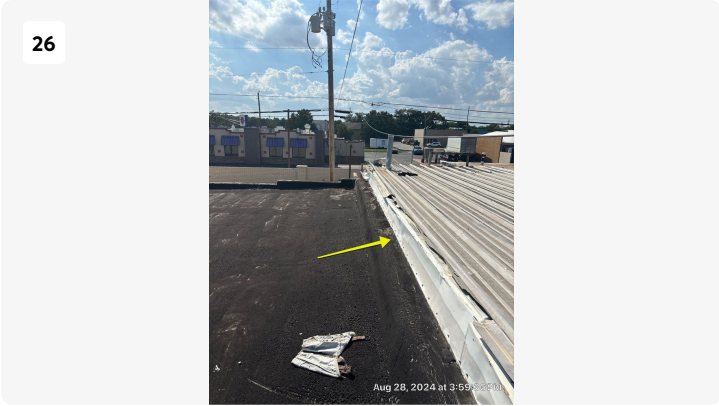
Transition between BUR roof and metal roof is going to be an issue.  
There will be leaks if membrane is not terminated correctly.

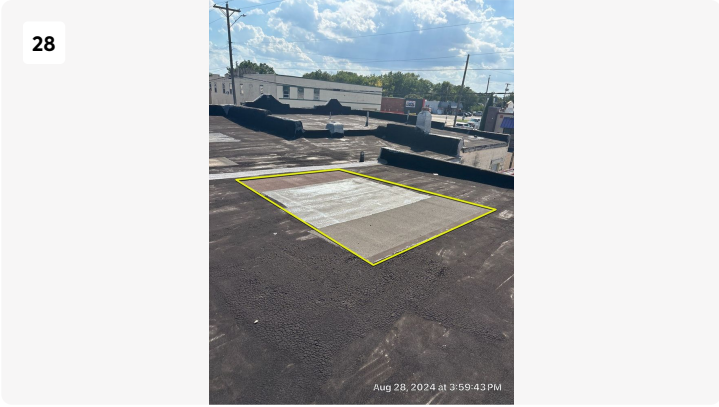
Additional shingle repairs on BUR roof.

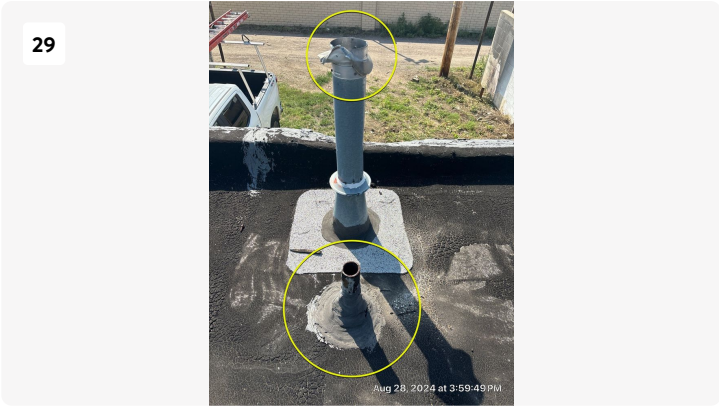
Vent cap missing and roof cement cracked out.

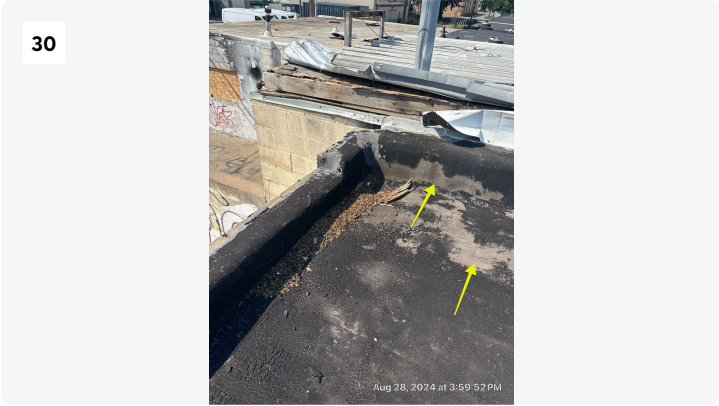
Field membrane and wall flashing both failing.

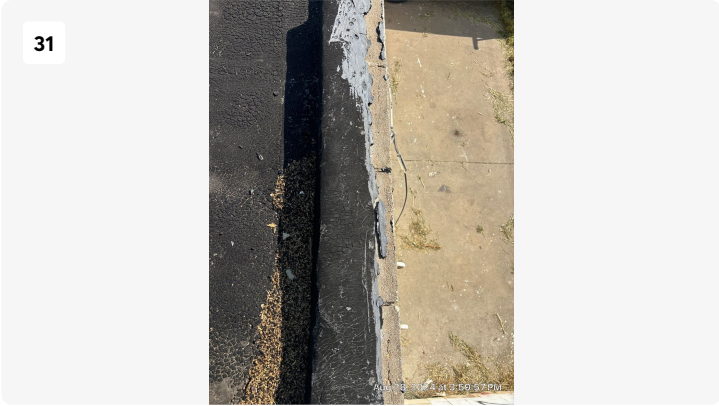
Wall termination failing.

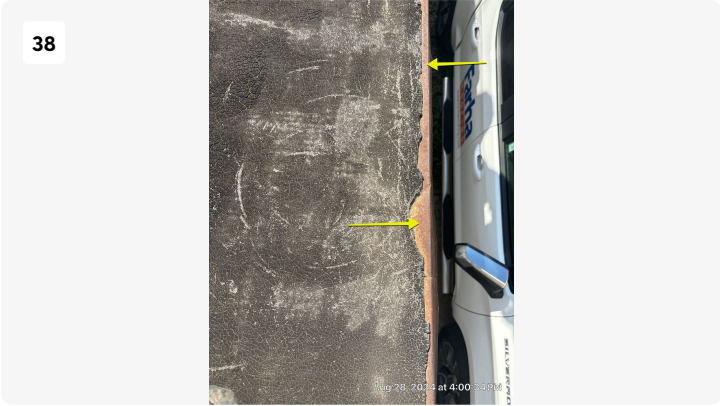
Metal edge rusted out.  
Needs removed, replaced and stripped in.

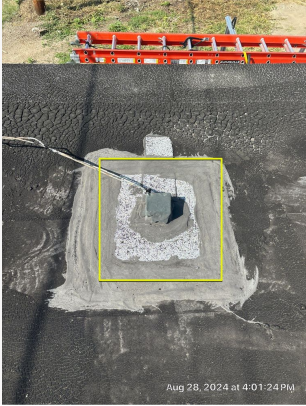
47

Defunct pitch pan, can be deleted.

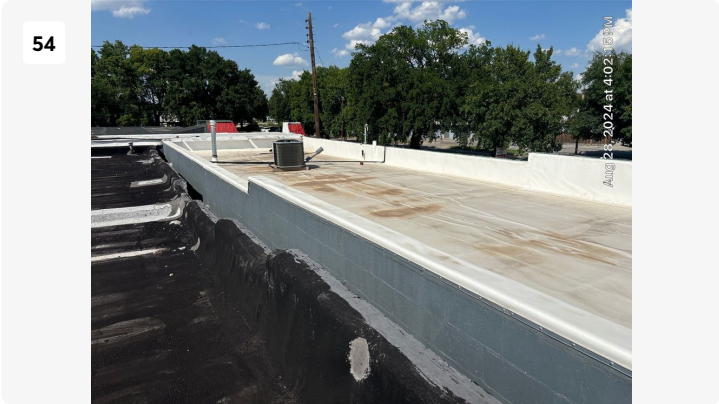
Roof next door has been roofed, and wall flashing terminated up and over the wall surface with termination bar. Good example of what 1028 could possibly look like.

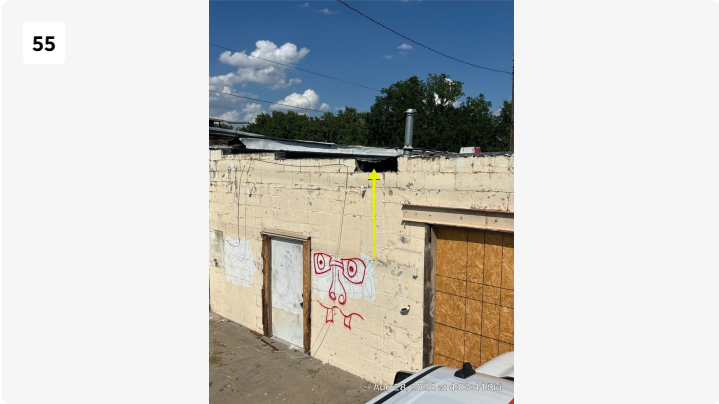
Missing masonry block.
