# Home Inspection Report

1230 S Reece Rd  
Goddard, KS 67052

Prepared for: Taylor Devlin

Prepared by: Central Home Inspections LLC  
P.O. Box 25  
Goddard, KS 67052

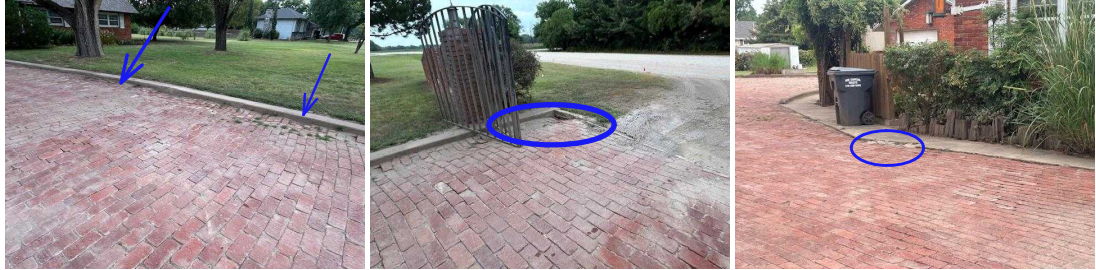
1. Needs Attention Driveway/Walks: Brick and Concrete - Areas have settled at driveway. Cracking and settling at front walk. Recommend budgeting for repair.

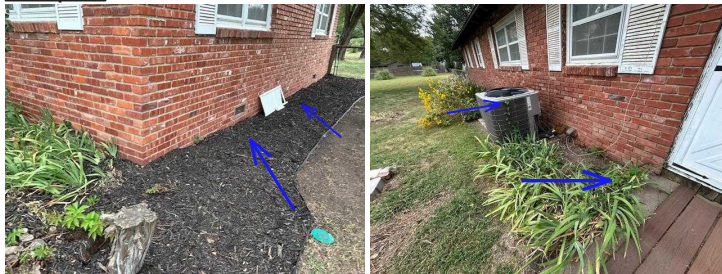
2. Acceptable Patio: Concrete - Common and typical cracking noted.  
3. Needs Attention Grading: Flat to negative slope - Flat to negative slope towards foundation in some areas. Recommend the addition or movement of existing dirt to improve grade. Pictures are a sample.

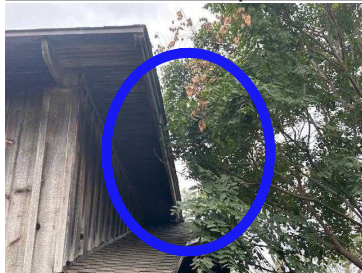
4. Needs Attention Vegetation: Shrubs/Tree - Vegetation was touching the house in areas. This leaves the exterior vulnerable to insect intrusion, and damage. Cutting back the vegetation is recommended to prevent more costly repairs in the future.

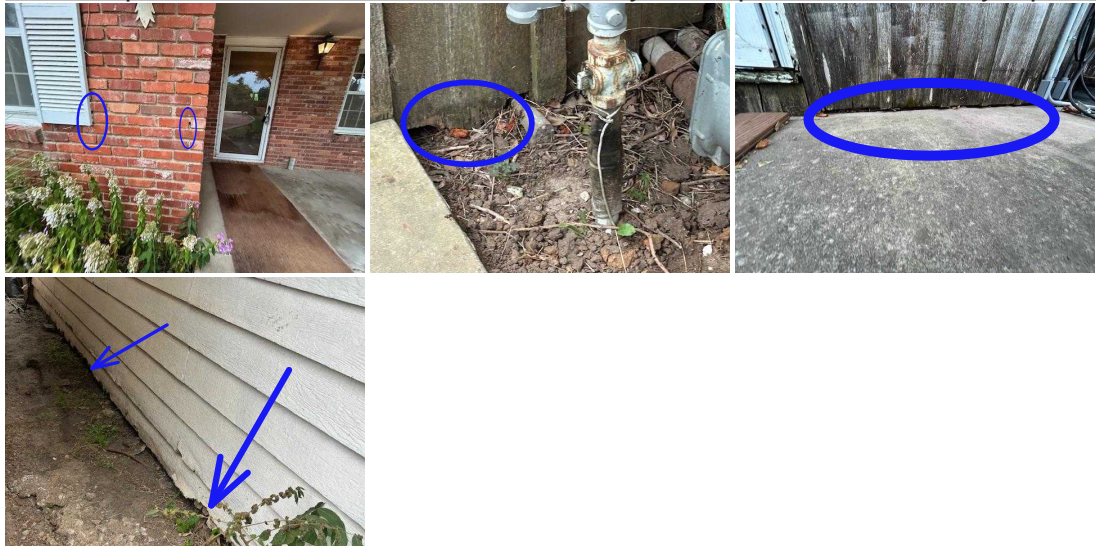
1. Needs Attention Type: Wood and Brick Veneer - Stair step cracking and mortar deterioration in areas. Common and typical for age and area. Recommend sealing mortar voids to prevent more costly repairs in the future. Exterior showed moisture damage in several areas around the home and garage. Recommend contacting a qualified contractor to evaluate and estimate the cost of repair. Pictures are a sample.

- Exterior was due for cleaning, scraping, caulking and sealing. These are basic home ownership duties that should be done every 5-7 years to prevent more costly repairs.

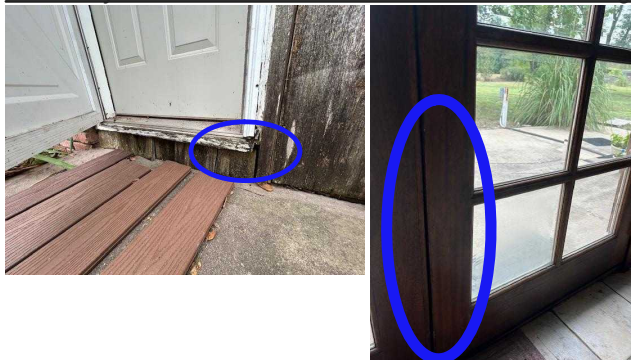
2. Acceptable Entry Doors: Wood  
3. Needs Attention Patio/Deck Doors: Wood - Main back door would not shut, they also need to be sealed. Laundry room door threshold had water damage. Recommend repair.

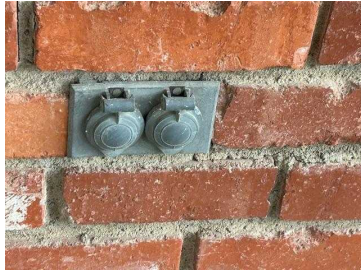
5. Needs Attention Exterior Electric Outlets: 110 VAC - Not GFCI protected which is common and typical for a home of this age. In modern construction it is required to have GFCI protection for safety on any outlet within 6 feet of running water. Recommend upgrading to GFCI protected outlets.

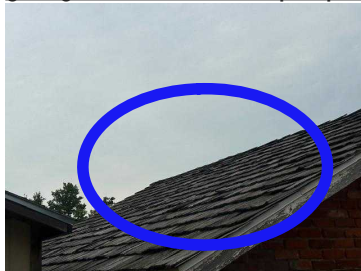
1. Method of Inspection: Ladder at eaves. Due to construction methods, pitch, weather conditions, or general safety reasons, sometimes roofs are not walked on.
2. Needs Attention Material: Asphalt shingle and Shake - Recommend budgeting to replace wood shake over garage for insurance purposes.

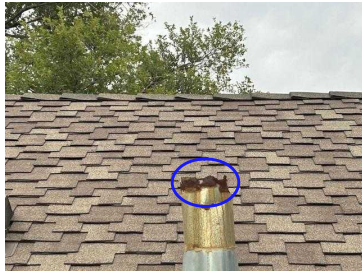
7. Acceptable Chimney: Metal pipe  
8. Needs Attention Flue/Flue Cap: Metal - Rusting and cap missing. Recommend repair by a licensed contractor.

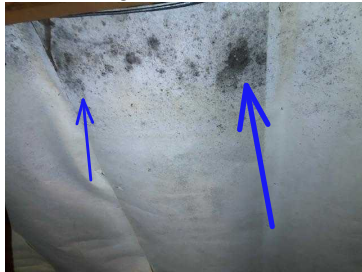
1. Method of Inspection: From the attic access. Due to the type of insulation present, construction methods or other safety concerns, some attics are not walked and the inspection is limited to the view from the access.  
2. Acceptable Roof Framing: Dimensional Wood Rafter  
3. Needs Attention Sheathing: Dimensional wood and plywood - Mold present in south attic at material covering sheathing. Recommend further evaluation and repair by a qualified contractor.

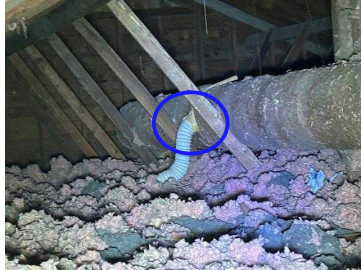
Bathroom Ventilation: (continued)

4. Acceptable Ventilation: Gable and roof vents  
5. Needs Attention Bathroom Ventilation: Improper termination - Bathroom ventilation appeared to be terminating into HVAC duct which is not allowed. Recommend extending to terminate within 12" of a roof vent to move humidity out of the attic.

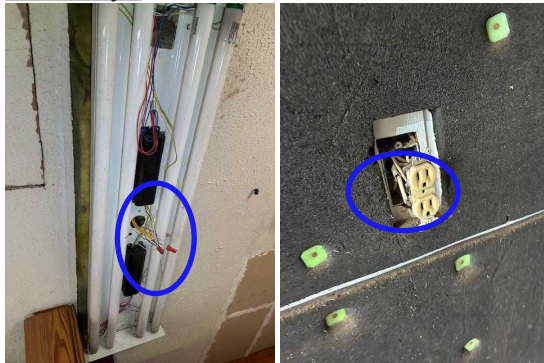
1. Type of Structure: Detached Car Spaces: 2
2. Acceptable Garage Doors: Metal
3. Acceptable Door Operation: Mechanized
4. Acceptable Door Opener: Functional - The automatic reverse was not tested due to the possibility of causing damage to the door or opener.
5. Needs Attention Electrical: 110 VAC outlets and lighting circuits - Lighting inoperable. Uncovered outlets. Recommend covering for safety purposes. Exposed electrical terminations should be in a box for safety.

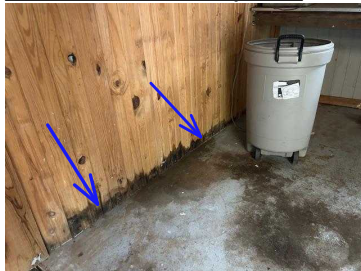
6. Needs Attention Walls: Paint - Indication of moisture intrusion on several walls. Recommend further evaluation and repair.

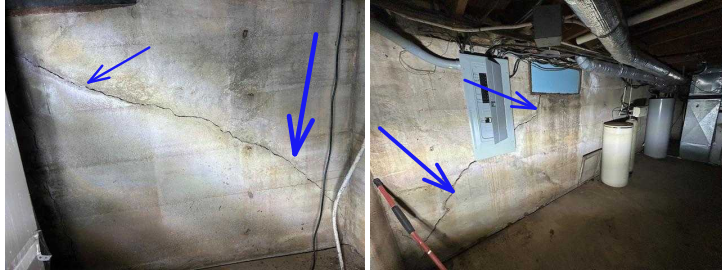
1. Acceptable Structure Type: Wood frame
2. Needs Attention Foundation: Poured - Stress cracking and inward movement in basement. See a structural engineer to evaluate and design a plan of repair.

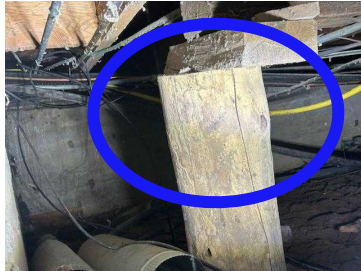
3. Acceptable Bearing Walls: Frame
4. Needs Attention Joists/Trusses: 2x Lumber - Wooden logs used as props in crawlspace, terminating directly on grade. See a structural engineer for further evaluation.

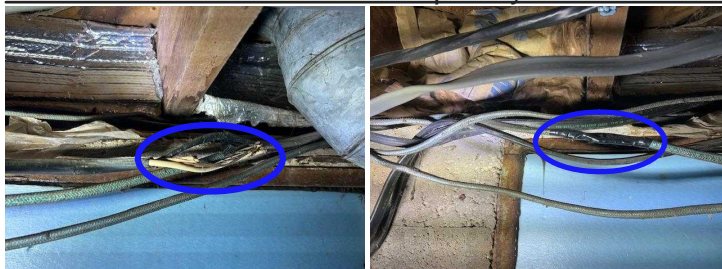
1. Service Size Amps: 200 Volts: 110-240 VAC
2. Acceptable Service: Aluminum
3. Acceptable 110 VAC Branch Circuits: Copper
4. Acceptable 220 VAC Branch Circuits: Copper and aluminum
5. Needs Attention Conductor Type: Non-metallic sheathed cable - Protective sheathing was missing or damaged in the basement. Recommend repair by a licensed electrician for safety.

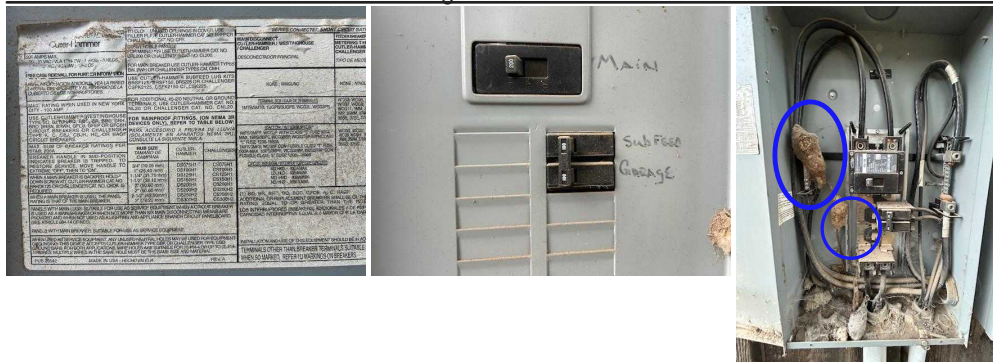
7. Needs Attention Manufacturer: Cutler-Hammer - Wasps nesting at bus bars and termination points which can lead to issues. Recommend having a licensed electrician clean and seal box.

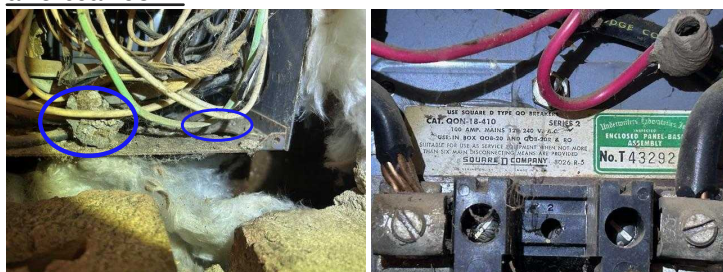
15. Needs Attention Manufacturer: Square D - Fire stops missing inside panel. Fire stops restrict air flow in case there were an arc inside of the panel. Recommend repair. Wasps nesting at bus bars and termination points which can lead to issues. Recommend having a licensed electrician clean and seal box.

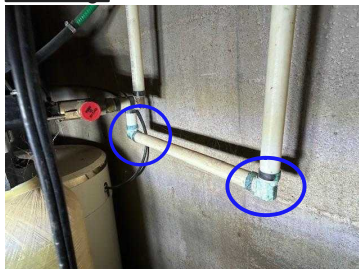
3. Needs Attention Water Lines: PEX and Copper - Indication of leaking (corrosion, staining) was observed at multiple connections mechanical room. Recommend repair by a licensed plumber to prevent leaking.

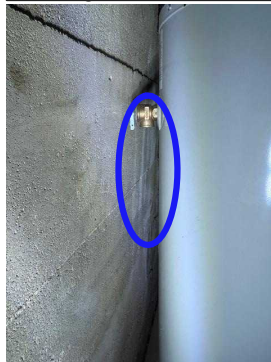
10. Needs Attention TPRV and Drain Tube: Copper - The discharge pipe is missing on the TPRV. Recommend adding a TPRV discharge pipe that terminates no more than 6" from the floor.

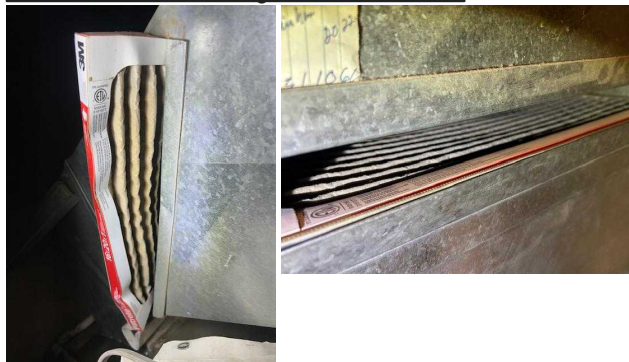
6. Needs Attention Blower Fan/Filter: Direct drive with disposable filter - Filters were past due for replacement.  
Recommend having units serviced.

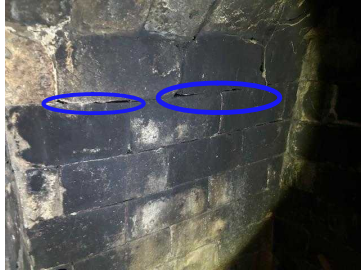
1. Needs Attention Fireplace Construction: Brick - Recommend filling voids around brick for safety purposes.

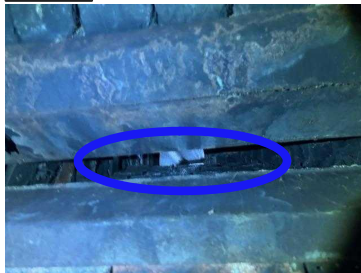
3. Needs Attention Flue/Vent: Clay Tile - Not Fully Visible - Due to the age of the fireplace and limited visibility, for safety purposes, I recommend a level II inspection by a licensed chimney contractor prior to use.

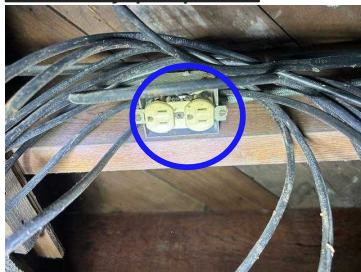
2. Needs Attention Electrical: 110 VAC outlets and lighting circuits - Uncovered outlets. Recommend covering for safety purposes.

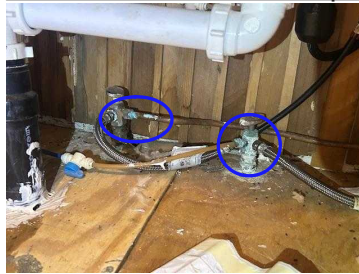
2. Acceptable Disposal: Functioned  
3. Needs Attention, Not Inspected Plumbing/Fixtures: Metal fixtures with PVC traps - Corrosion was present at shutoffs. Recommend repair.

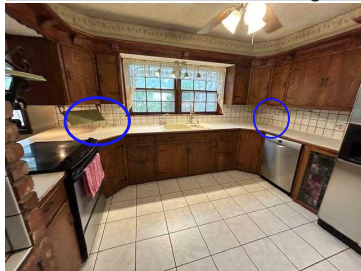
4. Needs Attention Electrical: 110 VAC - Not GFCI protected which is common and typical for a home of this age. In modern construction it is required to have GFCI protection for safety on any outlet within 6 feet of running water. Recommend upgrading to GFCI protected outlets.

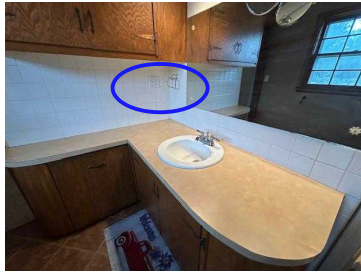
1. Needs Attention Electrical: 110 VAC - Not GFCI protected which is common and typical for a home of this age. In modern construction it is required to have GFCI protection for safety on any outlet within 6 feet of running water. Recommend upgrading to GFCI protected outlets.

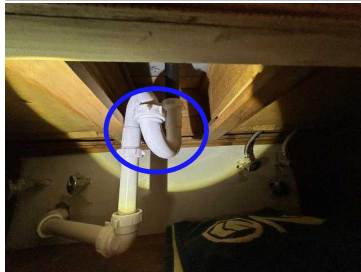
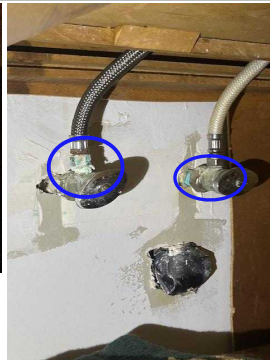
2. Needs Attention Faucets/Traps: Metal Fixtures with PVC Traps - An "S" trap has been used. S traps should be replaced during any new plumbing work as they are subject to siphoning problems. Replacement is sometimes difficult and thus the S traps are usually tolerated. Care should be taken to keep the trap "primed." Fixtures should be monitored for sewer odor.

- Corrosion was found at sink shutoffs. Recommend replacement to prevent leaking.

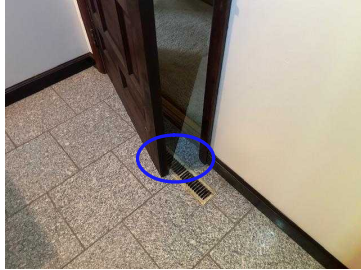
5. Needs Attention HVAC Source: Split system heating and cooling - Supply plenum cover at 1st floor guest bathroom was catching the door.

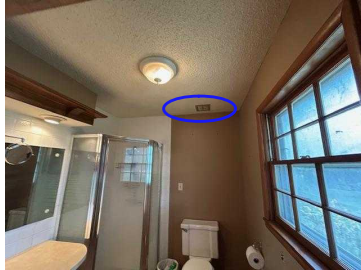
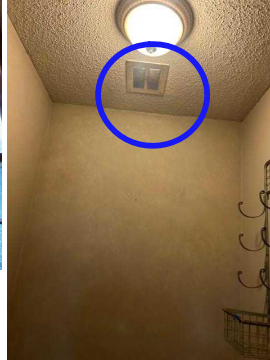
6. Needs Attention Ventilation: Electric ventilation fan - Fans inoperative. Recommend repair/replacement to operate as designed.

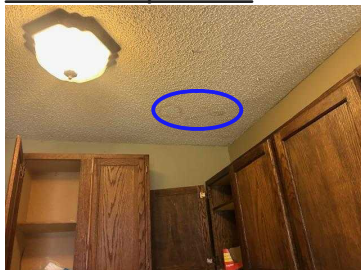
Ceiling: Texture paint - Staining was observed and noted in areas. No moisture was present at time of inspection.

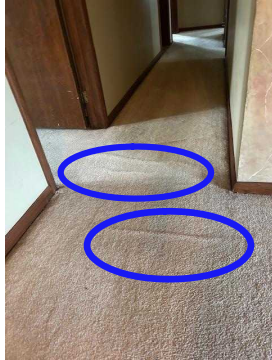
4. Needs Attention Floor: Carpet and Hard Surfaces - Carpet was loose in areas, creating trip hazards.  
Recommend having carpet stretched for safety purposes.

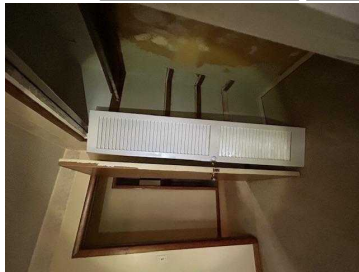
5. Needs Attention Doors: Hollow wood - Front bedroom closet door was removed.

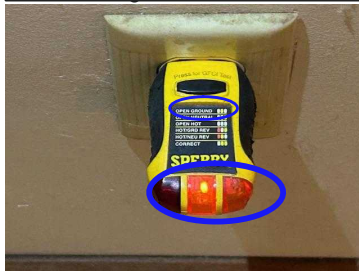
7. Needs Attention Electrical: 110 VAC outlets and lighting circuits - Three wire outlets were tested throughout the home and found to be ungrounded. Sometimes two wire outlets are replaced with three wire outlets to allow items to be plugged in without an adapter, however it gives a false perception that they would be grounded also. Recommend replacement with two wire or contacting a licensed electrician to evaluate and estimate the cost of upgrade.

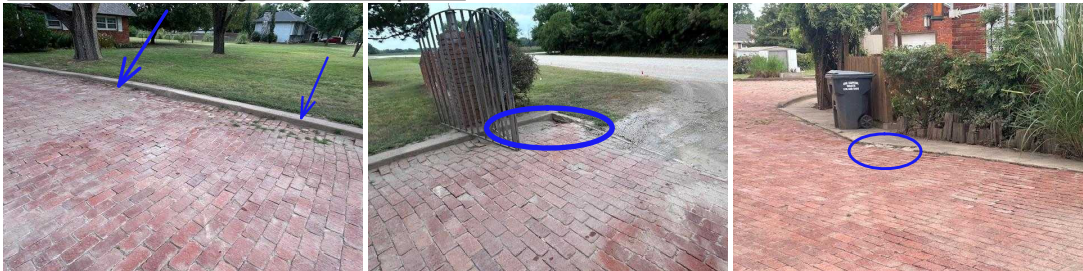
1. Driveway/Walks: Brick and Concrete - Areas have settled at driveway. Cracking and settling at front walk. Recommend budgeting for repair.

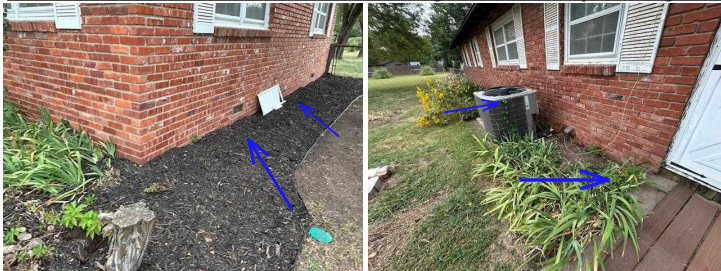
2. Grading: Flat to negative slope - Flat to negative slope towards foundation in some areas. Recommend the addition or movement of existing dirt to improve grade. Pictures are a sample.

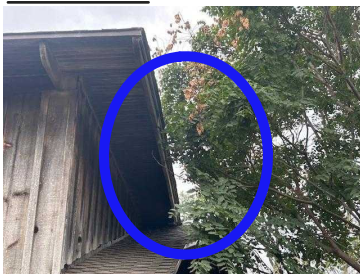
3. Vegetation: Shrubs/Tree - Vegetation was touching the house in areas. This leaves the exterior vulnerable to insect intrusion, and damage. Cutting back the vegetation is recommended to prevent more costly repairs in the future.

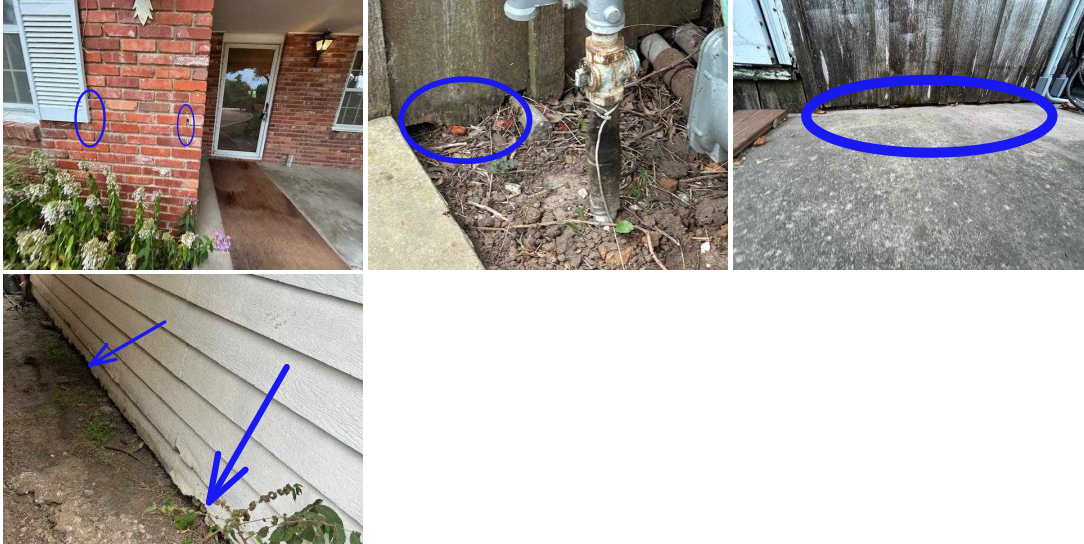
4. Most Sides are Similar Exterior Surface Type: Wood and Brick Veneer - Stair step cracking and mortar deterioration in areas. Common and typical for age and area. Recommend sealing mortar voids to prevent more costly repairs in the future. Exterior showed moisture damage in several areas around the home and garage. Recommend contacting a qualified contractor to evaluate and estimate the cost of repair. Pictures are a sample.

Exterior was due for cleaning, scraping, caulking and sealing. These are basic home ownership duties that should be done every 5-7 years to prevent more costly repairs.

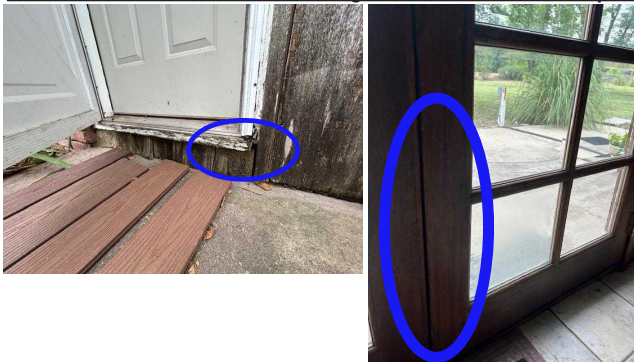
5. Patio/Deck Doors: Wood - Main back door would not shut, they also need to be sealed. Laundry room door threshold had water damage. Recommend repair.

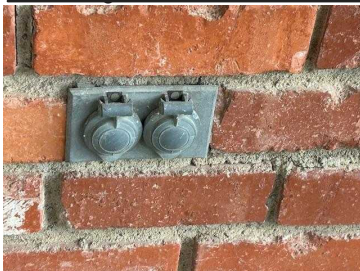
6. Exterior Electric Outlets: 110 VAC - Not GFCI protected which is common and typical for a home of this age. In modern construction it is required to have GFCI protection for safety on any outlet within 6 feet of running water. Recommend upgrading to GFCI protected outlets.

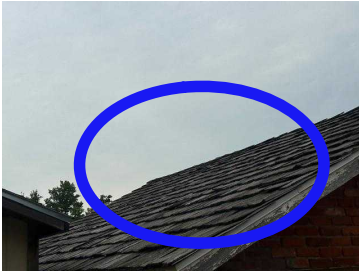
7. All Roofs Similar Roof Surface Material: Asphalt shingle and Shake - Recommend budgeting to replace wood shake over garage for insurance purposes.

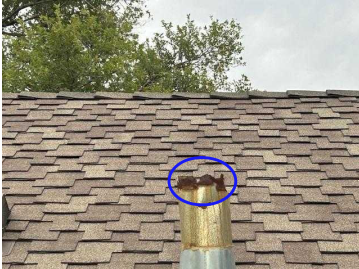
8. Gutters: None - There was no guttering system around the home. The guttering system is an important part of the water drainage system of the home. Recommend contacting a qualified contractor to evaluate and estimate the cost of installation.
9. Main Chimney Flue/Flue Cap: Metal - Rusting and cap missing. Recommend repair by a licensed contractor.

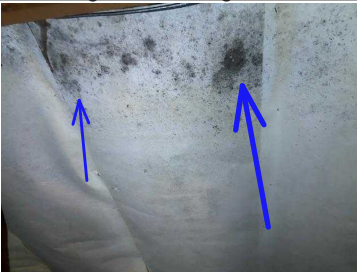
10. All Attics Similar Attic Sheathing: Dimensional wood and plywood - Mold present in south attic at material covering sheathing. Recommend further evaluation and repair by a qualified contractor.

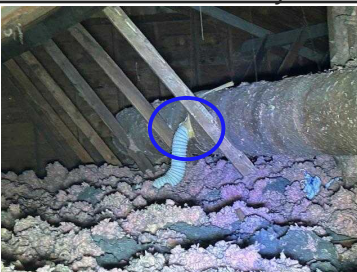
11. All Attics Similar Attic Bathroom Ventilation: Improper termination - Bathroom ventilation appeared to be terminating into HVAC duct which is not allowed. Recommend extending to terminate within 12" of a roof vent to move humidity out of the attic.

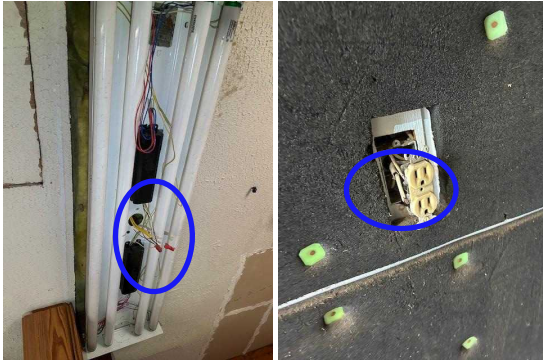
12. Detached Garage Electrical: 110 VAC outlets and lighting circuits - Lighting inoperable. Uncovered outlets. Recommend covering for safety purposes. Exposed electrical terminations should be in a box for safety.

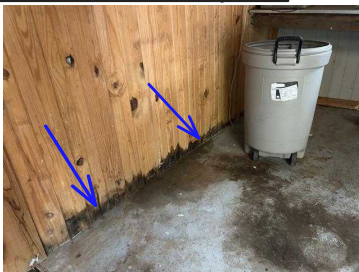
13. Detached Garage Walls: Paint - Indication of moisture intrusion on several walls. Recommend further evaluation and repair.

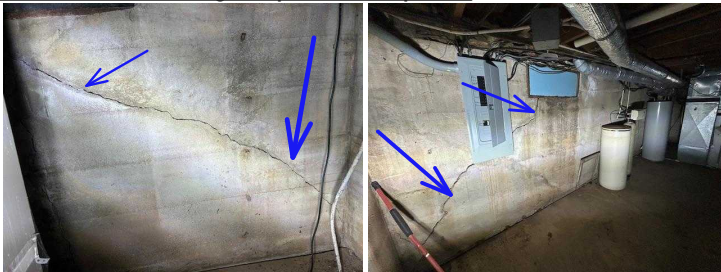
14. Foundation: Poured - Stress cracking and inward movement in basement. See a structural engineer to evaluate and design a plan of repair.

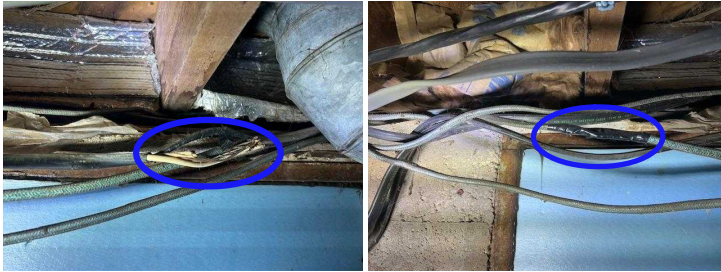
16. Conductor Type: Non-metallic sheathed cable - Protective sheathing was missing or damaged in the basement.  
Recommend repair by a licensed electrician for safety.

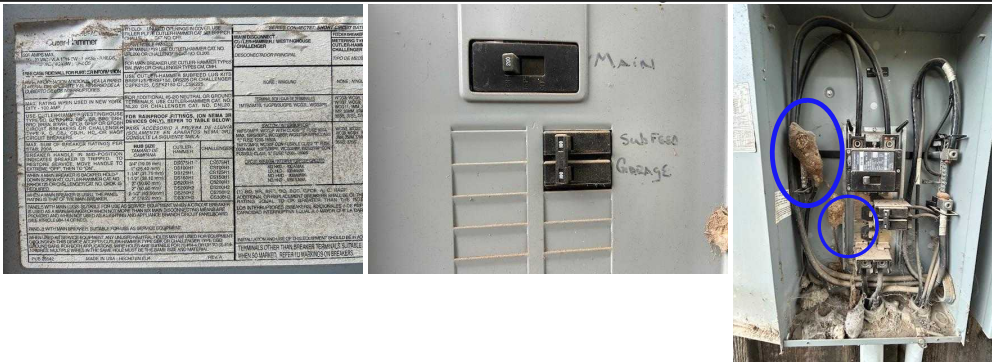
17. Exterior - Main Electric Panel Manufacturer: Cutler-Hammer - Wasps nesting at bus bars and termination points which can lead to issues.  
Recommend having a licensed electrician clean and seal box.

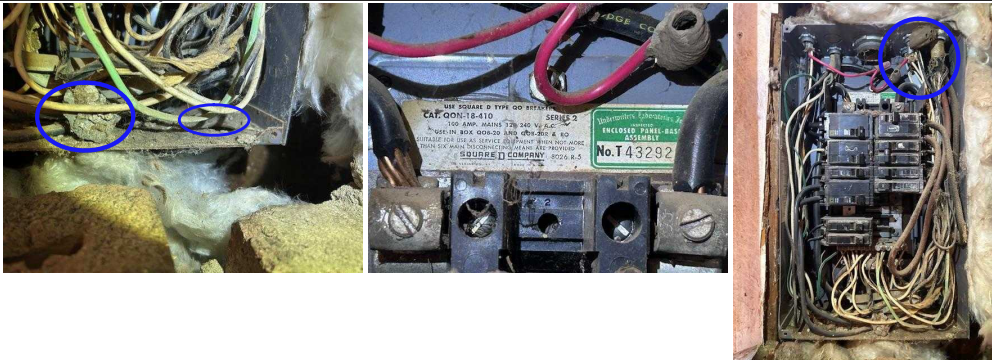
18. Garage - Subpanel Electric Panel Manufacturer: Square D - Fire stops missing inside panel. Fire stops restrict air flow in case there were an arc inside of the panel. Recommend repair. Wasps nesting at bus bars and termination points which can lead to issues. Recommend having a licensed electrician clean and seal box.

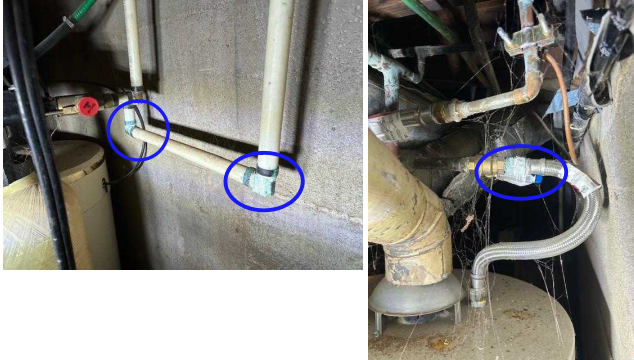
19. Water Lines: PEX and Copper - Indication of leaking (corrosion, staining) was observed at multiple connections mechanical room. Recommend repair by a licensed plumber to prevent leaking.

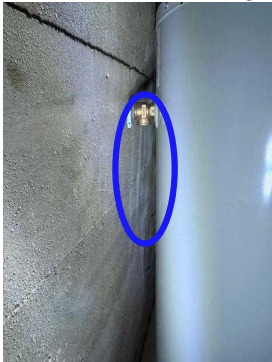
20. Basement Water Heater TPRV and Drain Tube: Copper - The discharge pipe is missing on the TPRV. Recommend adding a TPRV discharge pipe that terminates no more than 6" from the floor.

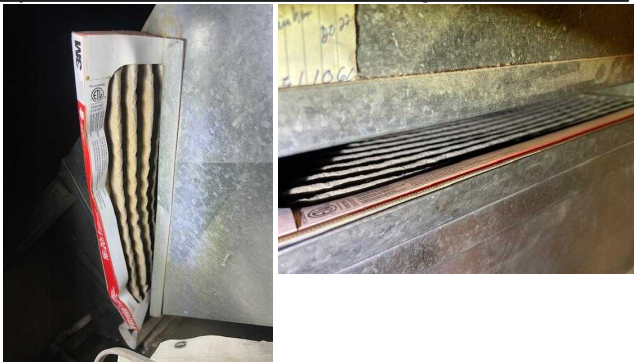
21. Both Similar Heating System Blower Fan/Filter: Direct drive with disposable filter - Filters were past due for replacement. Recommend having units serviced.

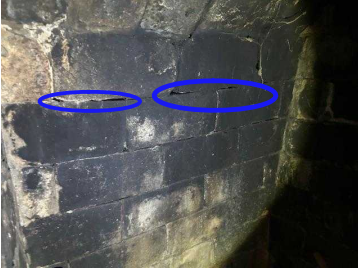
22. All Fireplaces Similar Fireplace Construction: Brick - Recommend filling voids around brick for safety purposes.

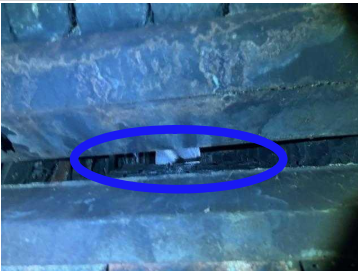
23. All Fireplaces Similar Fireplace Flue/Vent: Clay Tile - Not Fully Visible - Due to the age of the fireplace and limited visibility, for safety purposes, I recommend a level II inspection by a licensed chimney contractor prior to use.

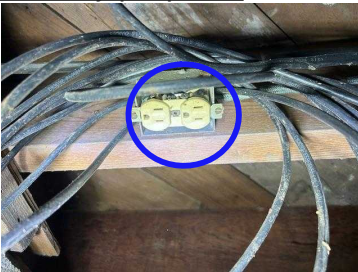
24. Main Basement Electrical: 110 VAC outlets and lighting circuits - Uncovered outlets. Recommend covering for safety purposes.

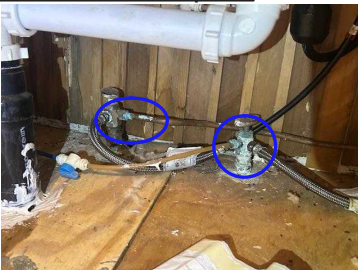
25. 1st Floor Kitchen Plumbing/Fixtures: Metal fixtures with PVC traps - Corrosion was present at shutoffs. Recommend repair.

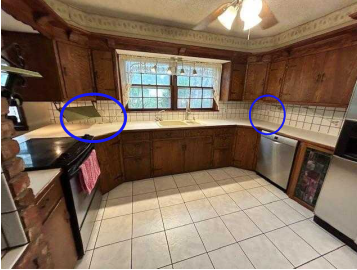
26. 1st Floor Kitchen Electrical: 110 VAC - Not GFCI protected which is common and typical for a home of this age. In modern construction it is required to have GFCI protection for safety on any outlet within 6 feet of running water. Recommend upgrading to GFCI protected outlets.

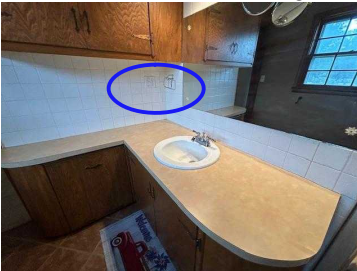
27. All Bathrooms Similar Bathroom Electrical: 110 VAC - Not GFCI protected which is common and typical for a home of this age. In modern construction it is required to have GFCI protection for safety on any outlet within 6 feet of running water. Recommend upgrading to GFCI protected outlets.

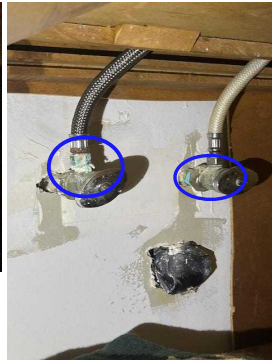
28. All Bathrooms Similar Bathroom Faucets/Traps: Metal Fixtures with PVC Traps - An "S" trap has been used. S traps should be replaced during any new plumbing work as they are subject to siphoning problems. Replacement is sometimes difficult and thus the S traps are usually tolerated. Care should be taken to keep the trap "primed." Fixtures should be monitored for sewer odor.

Corrosion was found at sink shutoffs. Recommend replacement to prevent leaking.

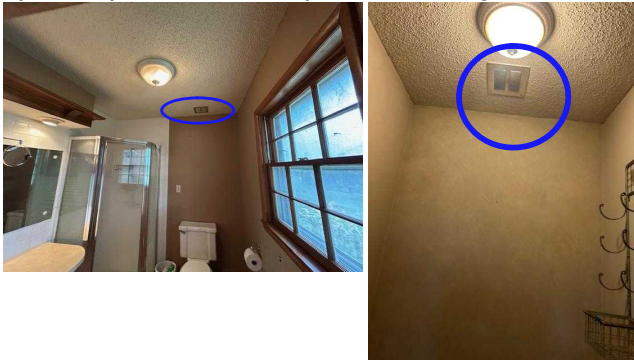
31. All Bathrooms Similar Bathroom Ventilation: Electric ventilation fan - Fans inoperative. Recommend repair/replacement to operate as designed.

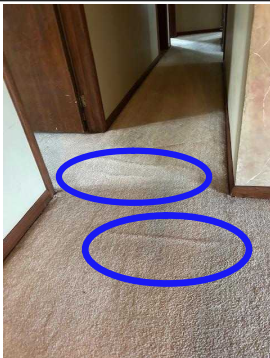
32. All Living Spaces Living Space Floor: Carpet and Hard Surfaces - Carpet was loose in areas, creating trip hazards. Recommend having carpet stretched for safety purposes.

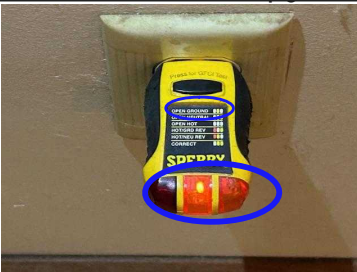
34. All Living Spaces Living Space Electrical: 110 VAC outlets and lighting circuits - Three wire outlets were tested throughout the home and found to be ungrounded. Sometimes two wire outlets are replaced with three wire outlets to allow items to be plugged in without an adapter, however it gives a false perception that they would be grounded also. Recommend replacement with two wire or contacting a licensed electrician to evaluate and estimate the cost of upgrade.

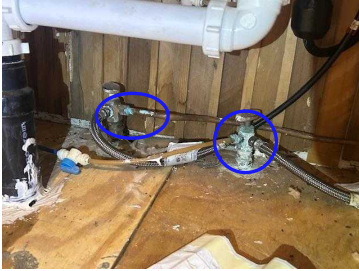
1. 1st Floor Kitchen Plumbing/Fixtures: Metal fixtures with PVC traps - Corrosion was present at shutoffs.  
Recommend repair.
