# Home Inspection Report

1230 S Reece Rd  
Goddard, KS 67052

Prepared for: Taylor Devlin

Prepared by: Central Home Inspections LLC  
P.O. Box 25  
Goddard, KS 67052

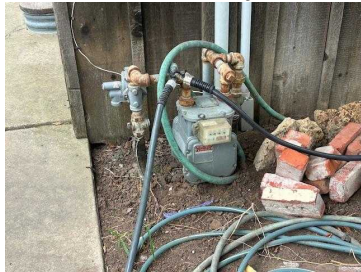
7. Acceptable

Gas Meter: Directly outside the home

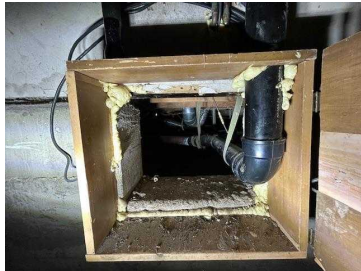
2. Acceptable

Access: Small

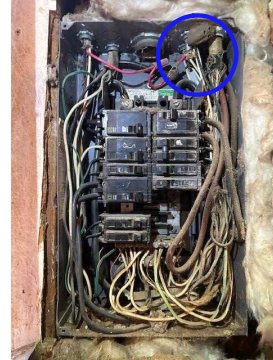
Manufacturer: (continued)

16. Maximum Capacity: 100 Amps

17. Acceptable Main Breaker Size: 100 Amps - Located at exterior.

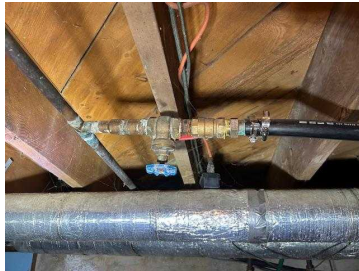
2. Acceptable

Main Water Shutoff: Basement

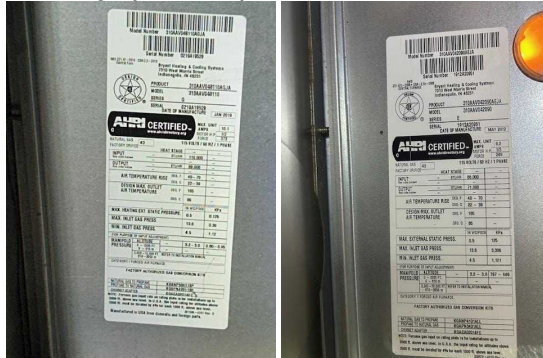
1. Acceptable Heating System Operation: Functional at time of inspection

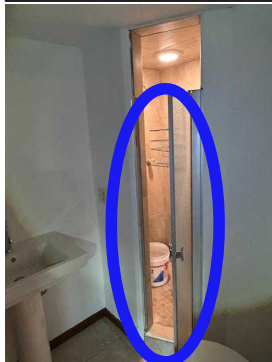
3. Needs Attention Tub/Shower/Surround: Porcelain tub and ceramic tile surround - NOTE: The inspector could not fit into the 2nd floor shower to test it. A bucket was underneath the shower head.

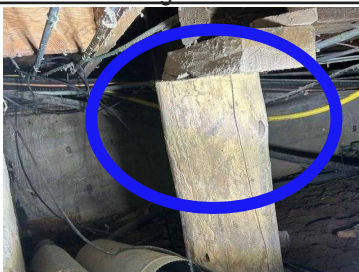
15. Joists/Trusses: 2x Lumber - Wooden logs used as props in crawlspace, terminating directly on grade. See a structural engineer for further evaluation.

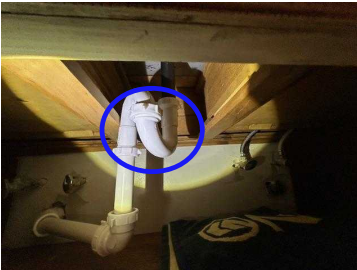
28. All Bathrooms Similar Bathroom Faucets/Traps: Metal Fixtures with PVC Traps - An "S" trap has been used. S traps should be replaced during any new plumbing work as they are subject to siphoning problems. Replacement is sometimes difficult and thus the S traps are usually tolerated. Care should be taken to keep the trap "primed." Fixtures should be monitored for sewer odor.

Corrosion was found at sink shutoffs. Recommend replacement to prevent leaking.

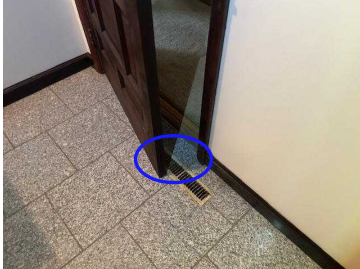
30. All Bathrooms Similar Bathroom HVAC Source: Split system heating and cooling - Supply plenum cover at 1st floor guest bathroom was catching the door.

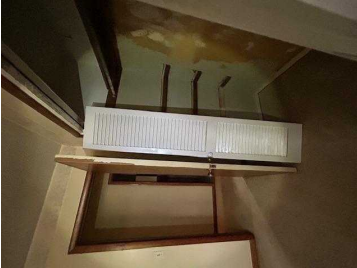
33. All Living Spaces Living Space Doors: Hollow wood - Front bedroom closet door was removed.
